Fault Evaluation Report FER-169
Palo Colorado and Sur Fault Zones, Monterey County

William A. Bryant
Associate Geologist
April 26, 1985

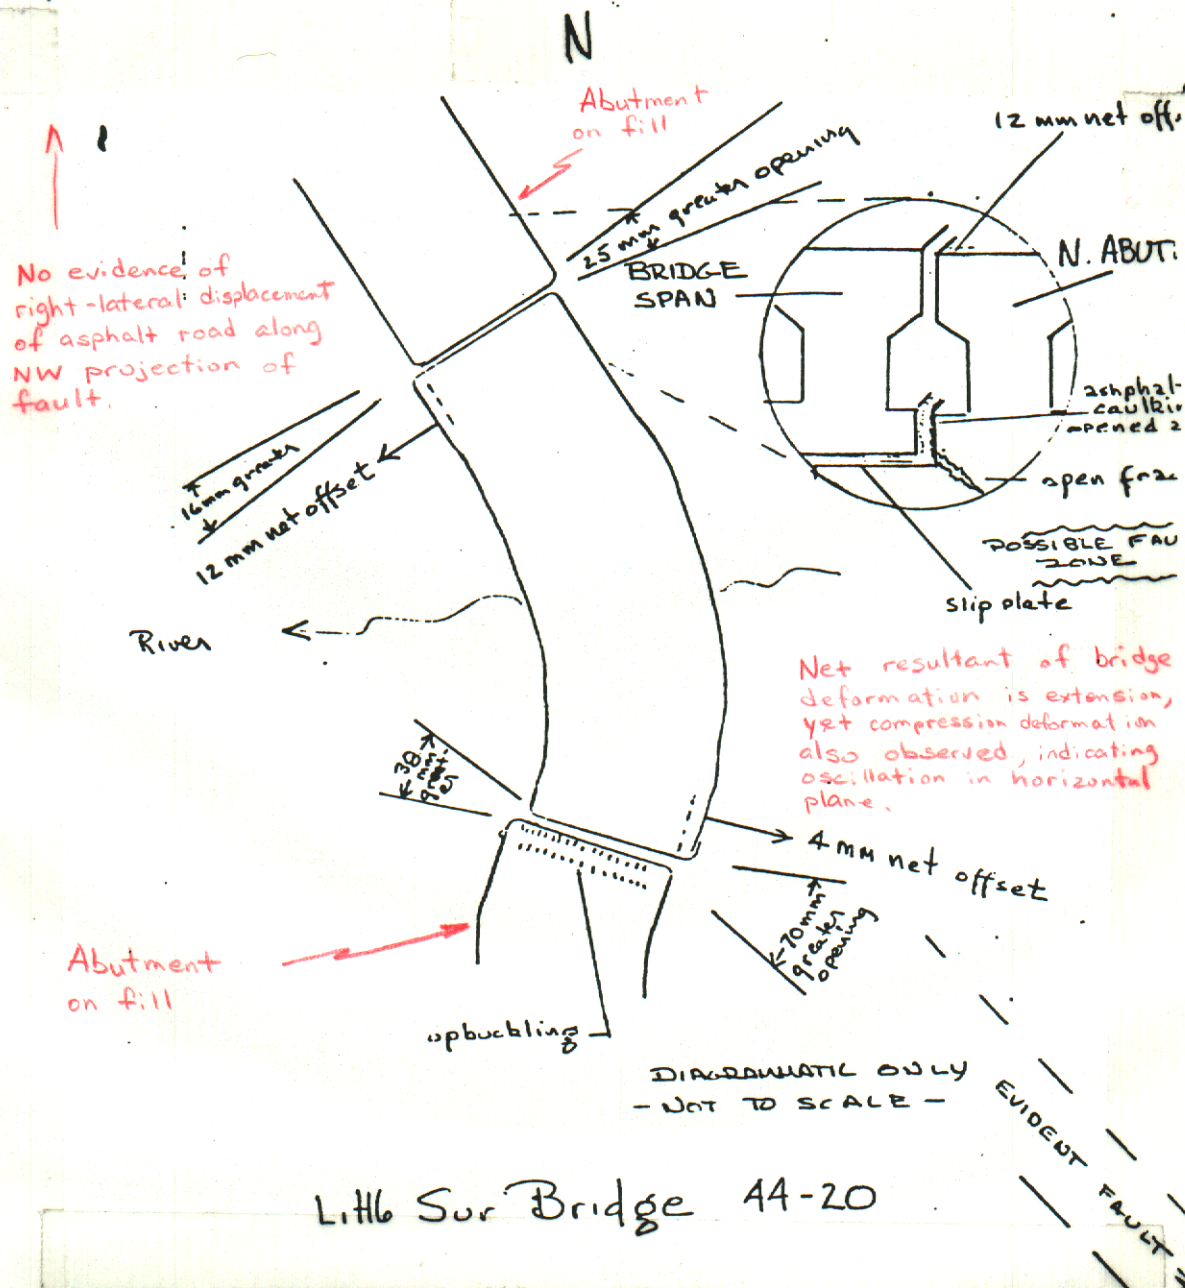
The bridge across the Little Sur River that was damaged during the January 1984 M5.0 earthquake was inspected by this writer in March 1985 (figures 2a, 3). Curry (1984) suggested that deformation of the bridge was caused by surface fault rupture along a segment of the Sur fault zone (Aquaje fault?) (locality 7, figures 2a, 3). However, the deformation was probably caused by shaking associated with the earthquake because: (1) the style of deformation is not consistent with what one would expect from right-slip (no evidence of clockwise rotation); (2) no evidence of right-lateral strike-slip deformation of the asphalt road was observed along the northwest projection of the inferred fault; (3) both the north and south bridge abutments are constructed on fill wedges; (4) there is no geomorphic evidence of recent strike-slip faulting along Curry's inferred fault; and (5) additional evidence of surface fault rupture associated with this event was not observed.

Figure 3 (to FER-169). Deformation of Highway 1 bridge across the Little Sur River observed by Curry (1984). Annotations in red by Bryant (this report), based on field observations in March 1985.

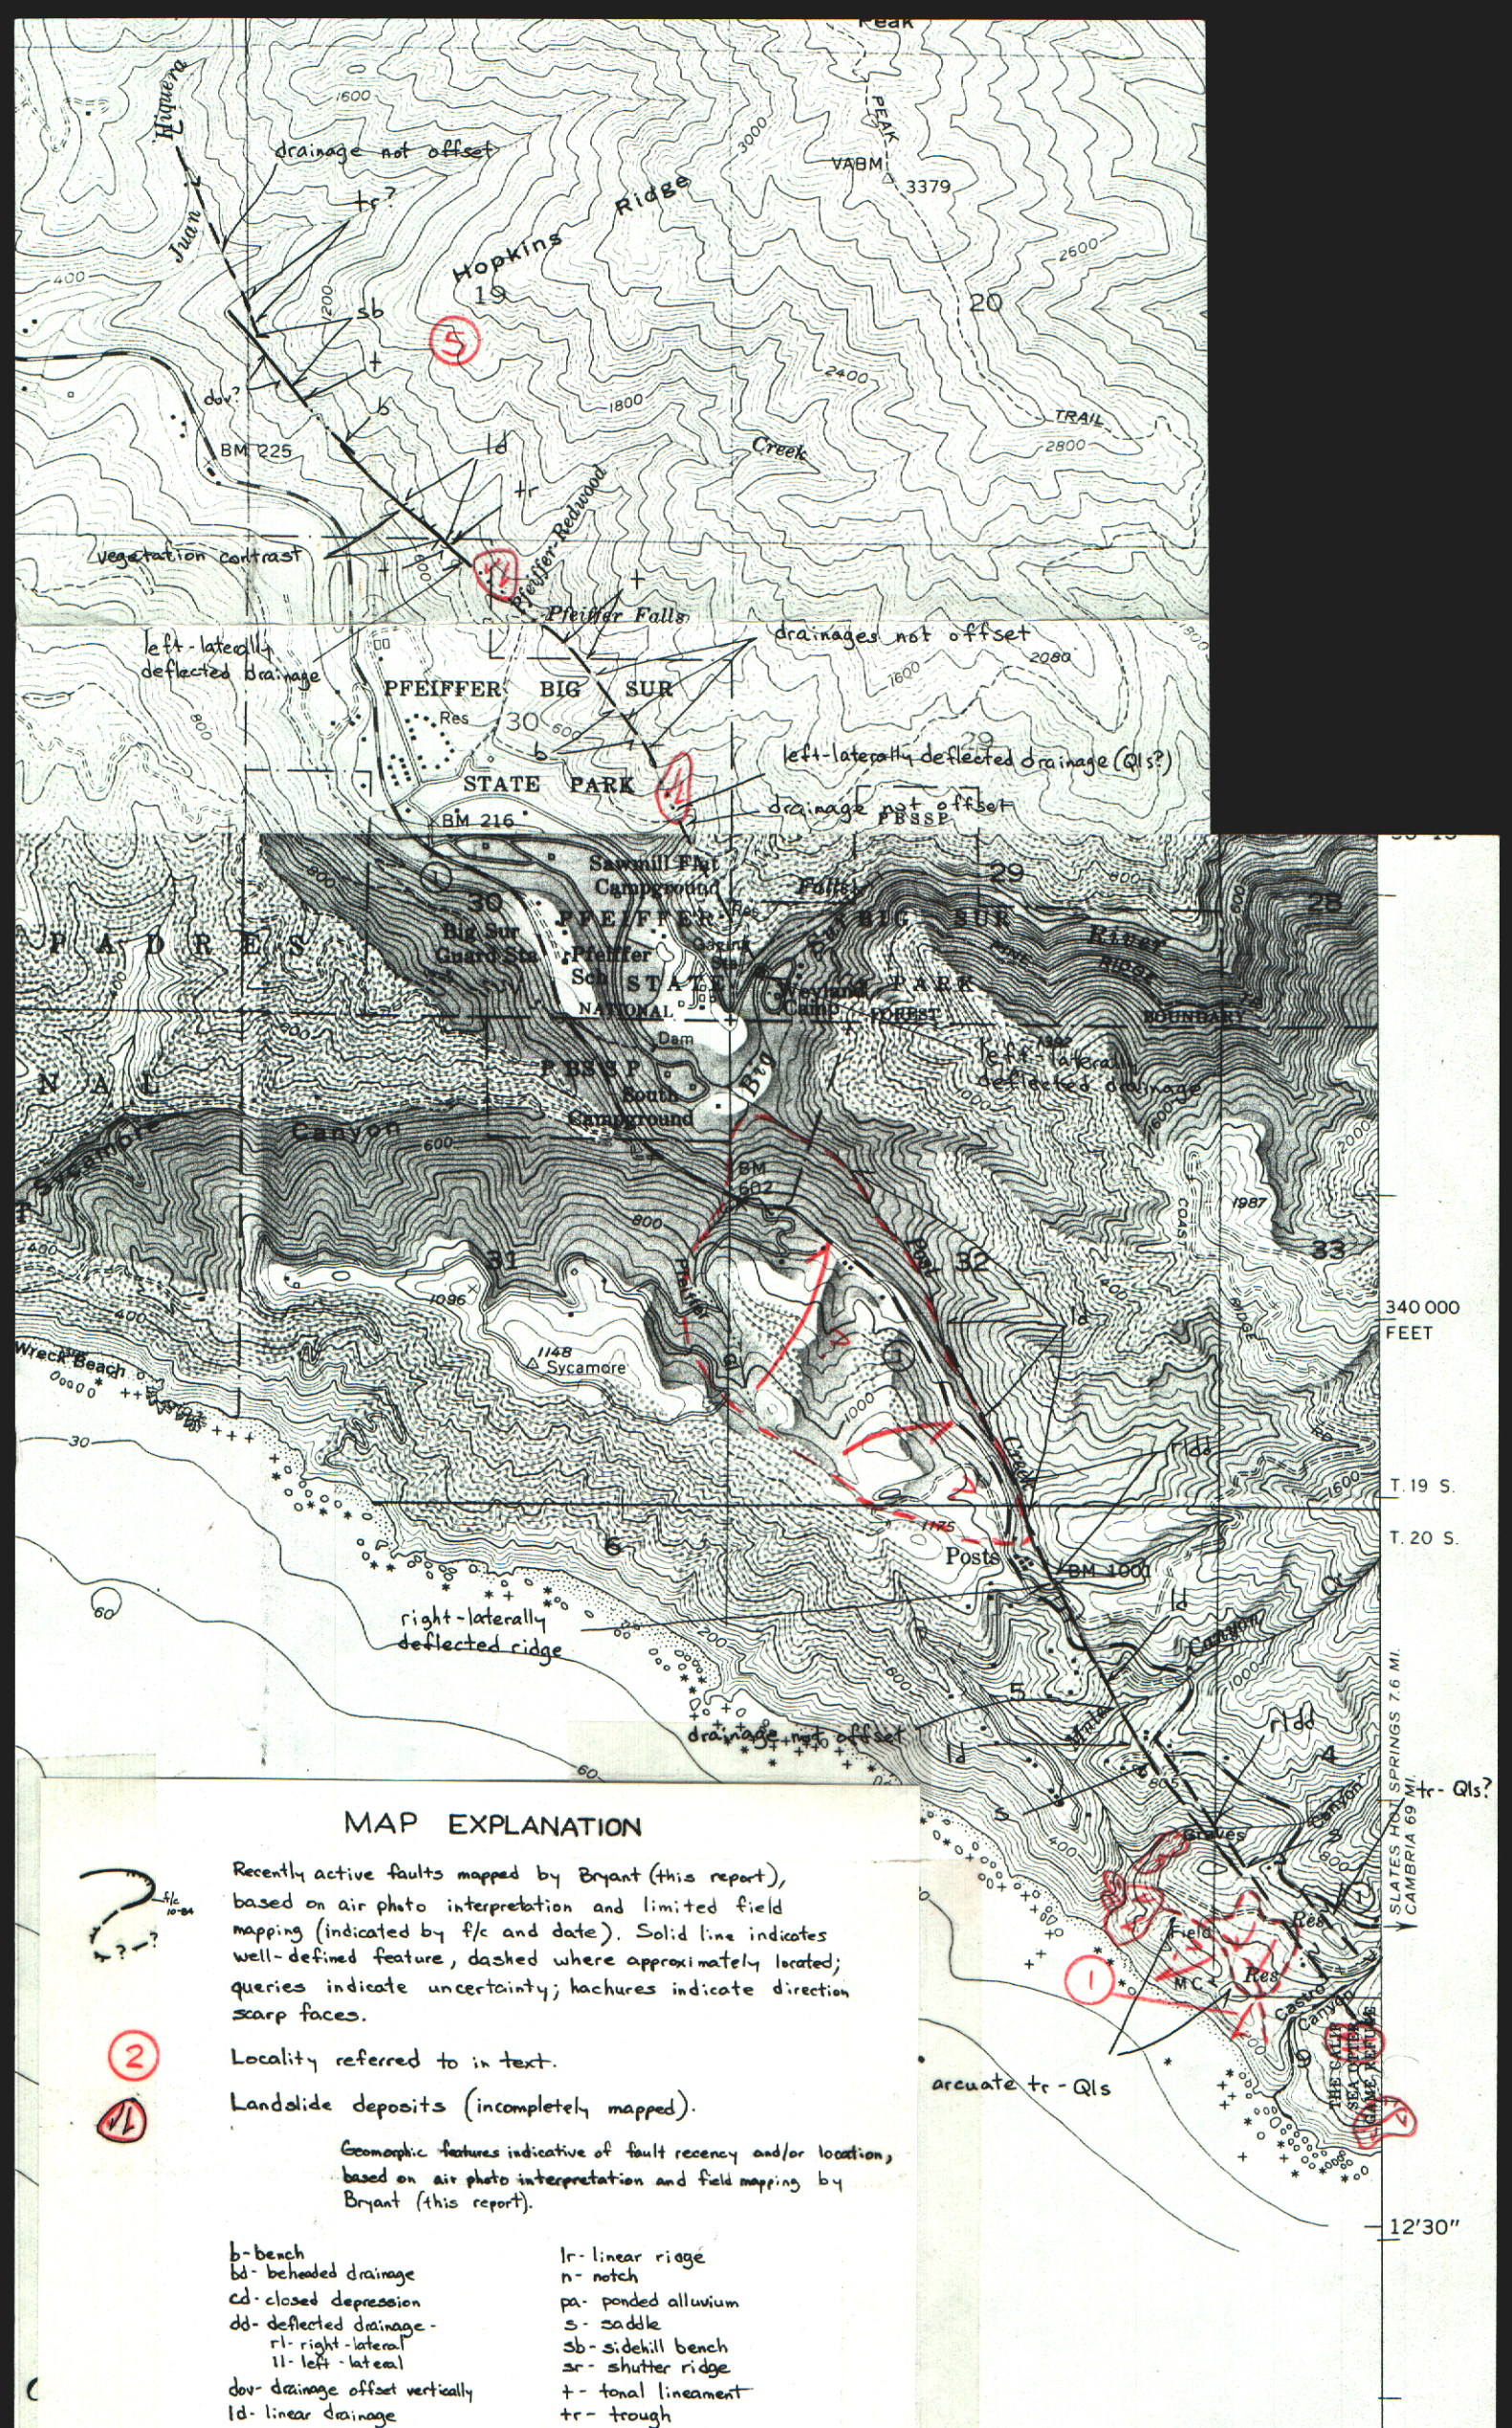
Traces of the Sur fault zone mapped by Dibblee (1973) and Gilbert (1971) (Serra Hill, Sur Thrust, Sur Hill Thrust, Rocky Creek, and Aquaje faults) generally are not well defined and are not characterized by geomorphic evidence of late Pleistocene and Holocene faulting (figure 2a). Marine terrace deposits at locality 4, which do not seem to be offset along the Rocky Creek fault, are similar to the terrace deposits described at localities 2 and 3 (figure 2a). Segments of the Big Sur and Gamboa faults locally are delineated by geomorphic features suggesting recent right-lateral strike-slip faulting (figures 2a, 2c, 4). In the Pfeiffer-Big Sur State Park area southeast to locality 1, the Big Sur fault zone is characterized by a sidehill bench, trough, both right- and left-laterally deflected drainages, and a right-laterally deflected ridge (figure 4). Systemmatically right-laterally deflected drainages were not observed, and it is not clear whether the geomorphic features at locality 1 (figures 2a, 4) delineate Holocene faulting. These features align with the Big Sur fault, but the general area is involved with landsliding. The closed depressions are man-modified and are not actually closed, based on interpretation of 1949 U.S.D.A. air photos. The lower trough west of the fault (locality 1, figure 4) is arcuate and is clearly formed by landsliding. The upper trough to the east is also caused by landsliding (figure 4).

Geomorphic evidence of possible late Quaternary strike-slip displacement was observed locally along the Big Sur fault from Pfeiffer-Big Sur State Park southeast to locality 1 (figure 4). Suggestive evidence of recent right-slip is indicated, but it is not certain whether the features are erosional or due to recent faulting. The closed depressions and sidehill bench cited by Curry (1984) as evidence for Holocene faulting at locality 1 (figure 4) are probably formed by landsliding.

Figure 4 (to FER-169). Recently active faults in the Big Sur and Pfeiffer Point 7.5-minute quadrangles mapped by Bryant (this report).

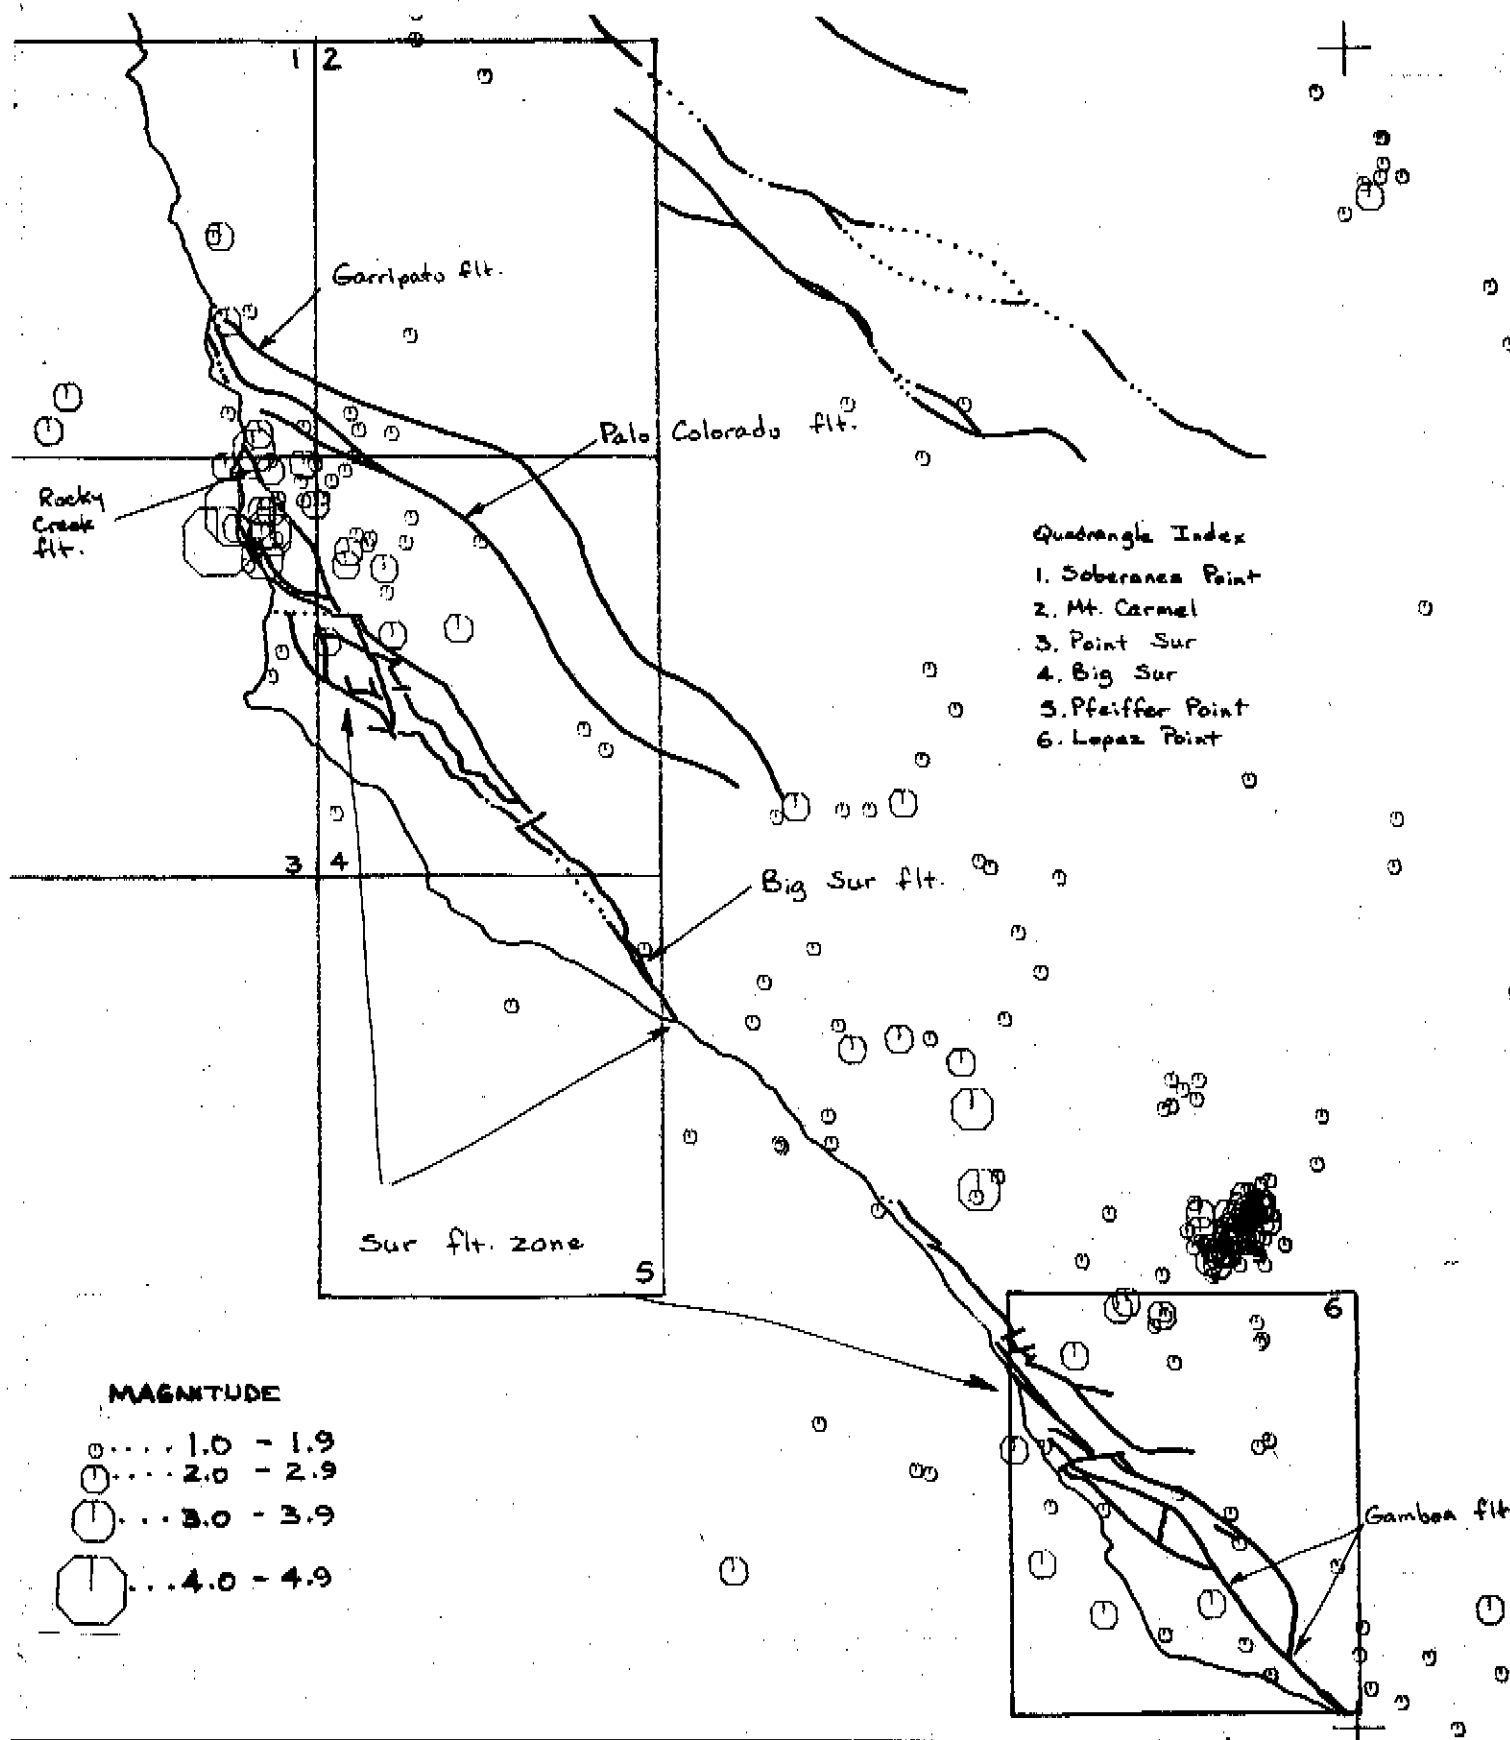
Seismicity in the study area is summarized in figure 5. Because most events in figure 5 are C quality, a direct association between earthquakes and specific faults cannot be made. However, segments of both the Palo Colorado and Sur fault zones seem to be seismically active at depth. The M5.0 January 23, 1984 earthquake, originally located near the Sur fault zone (figure 5), is now considered to have occurred offshore near the Palo Colorado fault zone (Lester, 1984; Eaton, 1984). Focal plane solutions for this event indicate either right-lateral strike-slip offset along a northwest-trending fault, or left-lateral strike-slip offset along an east-west-trending fault.

Figure 5 (to FER-169). Seismicity plot for the period 1969-1984 (C quality data) (U.S.G.S., 1985). Faults are from Buchanan-Banks and others (1978).
